June 3, 2014

Ms. Heather Carmichael, BA
Contract Administrator/Buyer
County of Johnson Texas
1102 E. Kilpatrick, Suite B
Cleburne, TX 76031**Re: Limited Roof Condition Assessment**Johnson County Corrections Center- Roof/Ceiling Condensation Assessment
1800 Ridgemar Drive
Cleburne, Texas
BES No. 6120

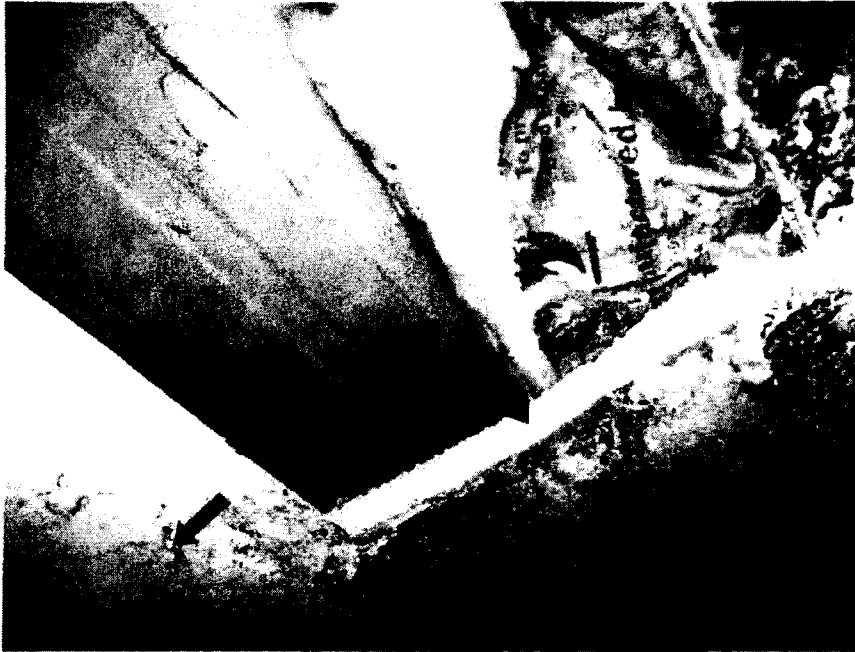
- General Observations (Photographs 4 through 8)
 - Brown stains on ceiling tiles throughout the area.
 - Displaced ceiling tiles.
 - Black residue on tiles and adjacent wall.
- Inspection Opening (Photographs 9 and 10)
 - Wood fiber tiles glued and screwed over paper-faced gypsum board.
 - Gypsum board and ceiling panels attached to steel zee framing.
 - Paper-faced fiberglass batt insulation (approximately 6-inches) was in the space between the metal roof and the paper-faced gypsum board.
 - Metal "R" profile type panel screwed down with metal fasteners to metal supports.
 - Moisture in core sample insulation (moisture not measured – wet to the touch in fiberglass insulation).
 - Stains and corrosion associated with a roof leak were not observed at this location.

At Building 2, Area B, the presence of significant and widespread stains on the ceiling finish, absence of stains on the roof framing members, and wet conditions present in the fiberglass insulation is consistent with condensation forming within and/or above the ceiling line. At this location gypsum sheathing and paper-faced fiberglass insulation were present above the wood fiber ceiling tiles.

Photograph 9: Area 2-B – Gypsum Sheathing (Red Arrow) with Wood Fiber Ceiling Tile (Blue Arrow)

At locations where two layers of ceiling finish and/or wet ceiling materials/insulation are present (wood fiber tile and gypsum), the entire ceiling finish and wet insulation should be removed. These materials pose a falling hazard and may contribute to the presence of mold growth. Steel framing should be inspected and areas with minimal to moderate rust should be brushed and painted to protect the steel. Members with significant steel distress should be remediated under the guidance of a qualified Professional Engineer. Additionally, the underside of the steel deck and framing should be inspected to determine if sources of water infiltration through the roof are present. After roof and framing member remediation is complete, a suspended gypsum ceiling system should be installed. The ceiling system

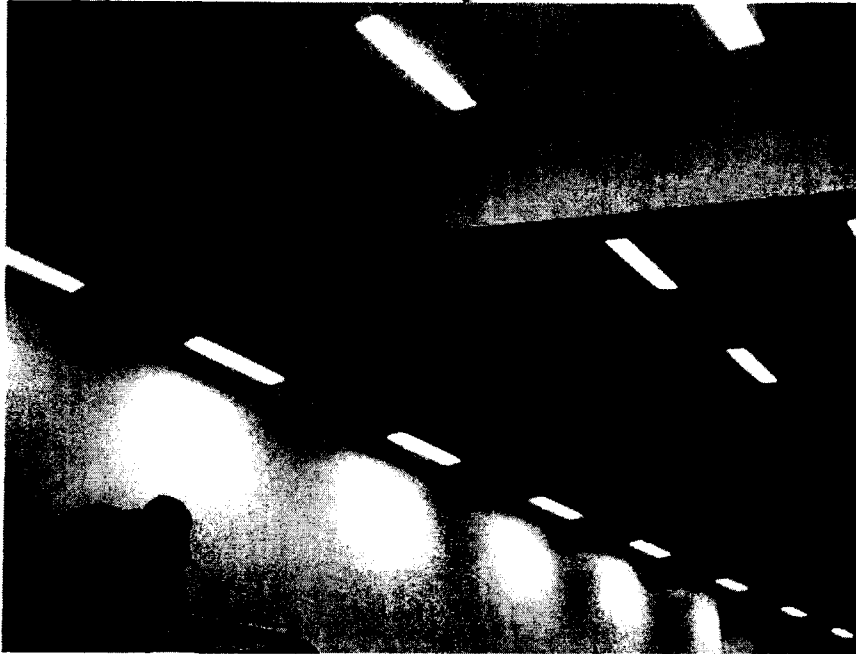
- General Observations (Photographs 16 and 17)
 - Limited brown stains on ceiling tiles throughout the area, primarily along suspect framing member lines.
- Inspection Openings (Photographs 18 and 19)
 - Wood fiber tiles fastened to framing members.
 - Foil-faced fiberglass batt insulation above the tiles.
 - No detectable moisture was present in the insulation.

The significant reduction in staining at Building 3, Area A appears to be associated with the presence of the foil vapor retarding membrane. It is likely that this layer is reducing the amount of vapor moving from the interior environment into the fiberglass insulation. Operational showers within the areas would contribute significantly to the humidity within the indoor environment and would exacerbate the condensation and visible damage. Therefore, the conditions resulting in the condensation are likely associated with high interior humidity and cooler exterior temperatures. Additionally, at Building 3 Area A, the limited patterns of stains on the tiles are consistent with 'ghosting' along the framing member lines. This often results when the temperature of the framing members is cooler than the adjacent insulation area. The above-noted conditions point toward fall, winter, spring type conditions.

Photograph 16: Area 3-A – Limited Stains at Ceiling

Photograph 17: Area 3-A - Limited Stains at Ceiling
