June 3, 2014

Ms. Heather Carmichael, BA
Contract Administrator/Buyer
County of Johnson Texas
1102 E. Kilpatrick, Suite B
Cleburne, TX 76031**Re: Limited Roof Condition Assessment**Johnson County Corrections Center- Roof/Ceiling Condensation Assessment
1800 Ridgemar Drive
Cleburne, Texas
BES No. 6120

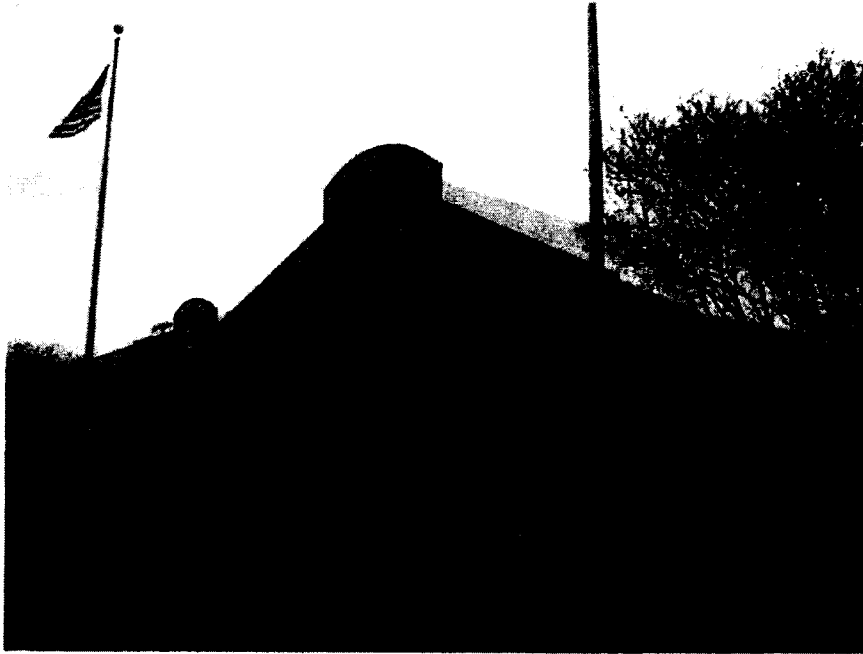
The Johnson County Corrections Center buildings 2 and 3 were reportedly constructed in 2005 and 2007 respectively (Photograph 1). The walls consist of concrete and the roofing consists of "R" type metal profile panel. Each building observed had 4 quadrants (A-D) with a central control center between the 4 units. An attic area was present between the units. Drawings for the buildings were not available for review during the on-site assessment.

Photograph 1: General Site
